WADC TECHNICAL REPORT 53-192

## MECHANISM OF RAIN EROSION

Part XIII. Mechanism Studies on Neoprene Coatings

*Olive G. Engel*

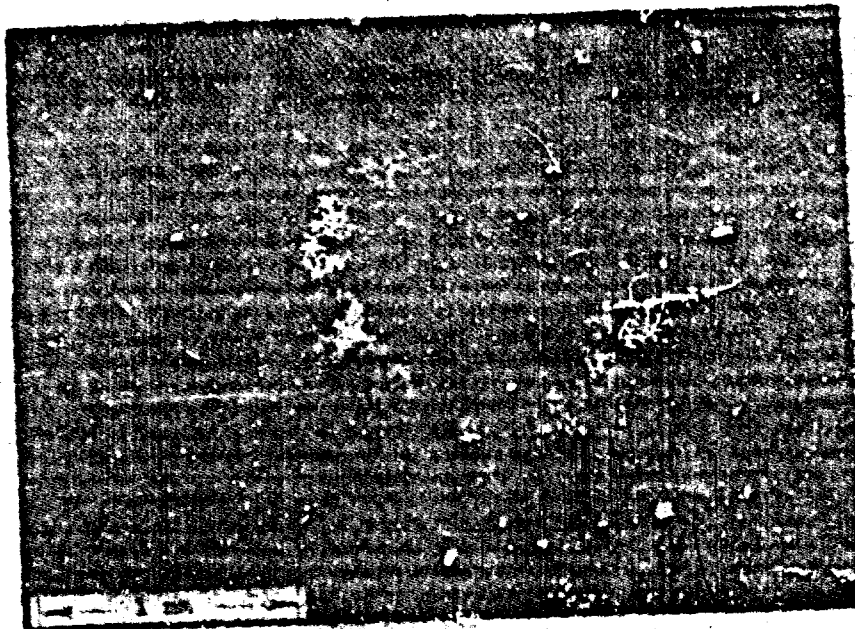
FIGURE 5 STRUCTURE OF WATERDROP IMPINGEMENT ADHESION  
OF MTH 80-539 NEOPRENE

It is possible that these circles of abrasion may be caused by the radial flow of individual waterdrops after the neoprene surface has become weakened by other waterdrop blows that were not themselves able to cause visible damage. The circles are not caused by every waterdrop that impinges against the specimen because, if this were the case, there would be so many circles of abrasion after 1.5 min of test at a velocity of 600 mi/hr in 1-in./hr rain that they would overlap. If these circles are caused by the radial flow of water from single drops, the wrinkles or trenches of which they are composed should be perpendicular to radii of the flow. This may be true of the circle of abrasion in picture 1 of Figure 5, but in the circle of abrasion shown in picture 2 of Figure 5 the trenches seem all to be oriented in the same direction.

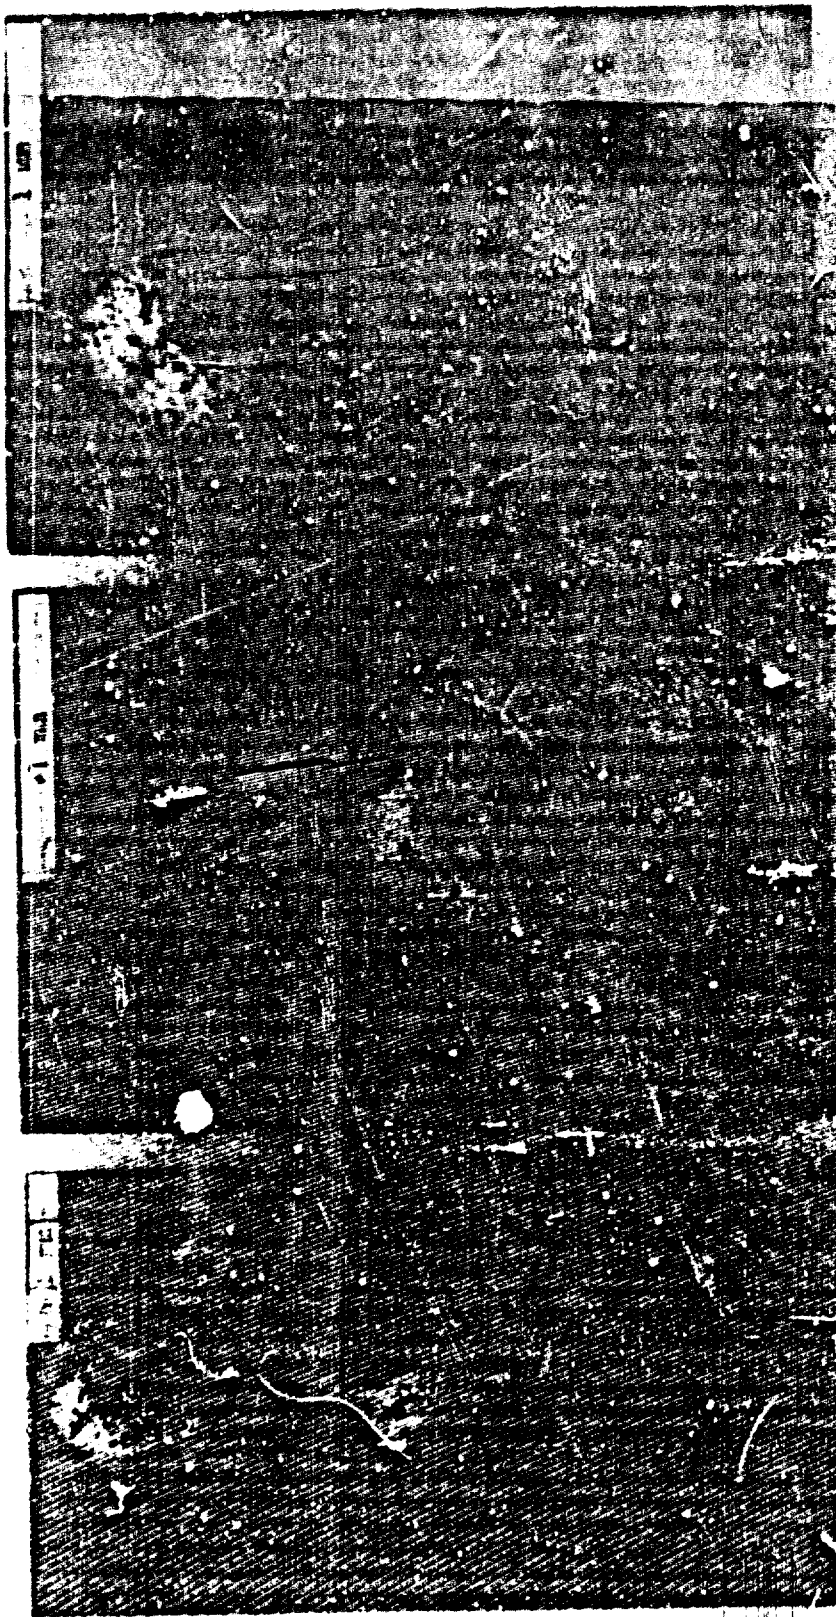
FIGURE 6. SEQUENCE OF A SINGLE DAMAGE MARK PRODUCED ON MM PC-539 IN WATER BY  
IMPINGEMENT OF WATERDROPS AT A VELOCITY OF 980 FT/SEC

1. AT LOW MAGNIFICATION
2. WITH CAMERA FOCUSED AT LEFT EDGE OF THE MARK
3. WITH CAMERA FOCUSED AT RIGHT EDGE OF THE MARK

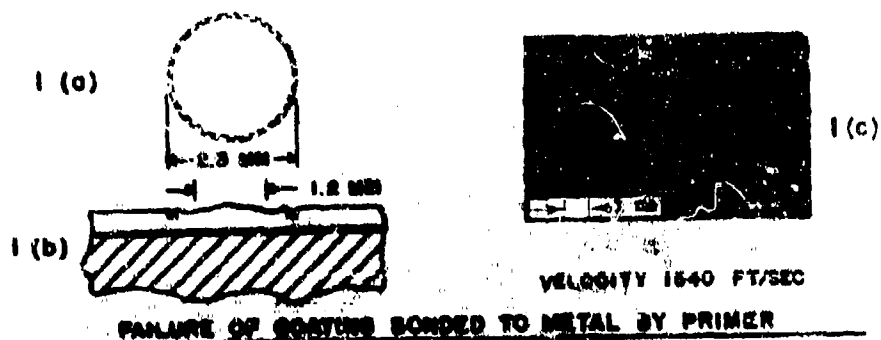
The damage mark produced at an impingement velocity of 2,480 ft/sec is shown in picture 2(c) of Figure 10. This damage mark consists of a central mound in the coating surrounded by a circular fold of coating. Dimensions of the damage mark are shown in sketches 2(a) and 2(b) at the left of the picture.

It can be seen that the diameter of the circular fold of coating is much larger than the diameter of the circle of cutting (rubber abrasion) seen in picture 1(c). Inspection of this damage mark with a stereoscopic microscope revealed that the circle of cutting exists at the base of the fold of coating and is concealed by the overhang of the fold itself. Although the radius of curvature of the fold is very small there are no cuts in the coating along the top of the fold.

It would appear that the first stage in the formation of this damage mark was the same as that shown in picture 1(c). The shear stress exerted by the radial flow of water from the drop was apparently great enough to break the primer bond and move the coating out into a radial stretch that was severe enough to induce permanent set. The fact that there are no cuts in the acute bending of this fold of coating is evidence that the circle of cutting shown in picture 1(c) is rubber abrasion and is not the result of a tensile failure at the periphery of a disk-shaped depression.

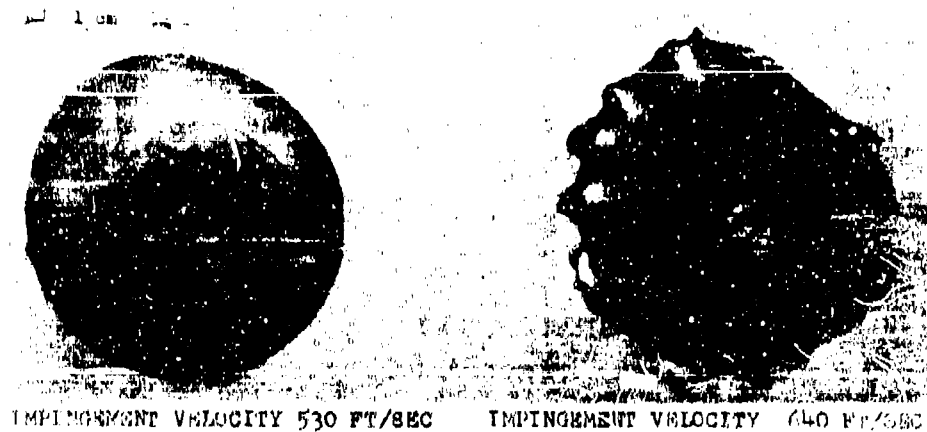
FIGURE 15 RESPONSE OF THREE NEOPRENE COATINGS TO IMPINGEMENT WITH  
DEFORMING LEAD PELLETS

Magnified views of the damage marks produced on the three neoprene coatings at a pellet velocity of 490 ft/sec are shown in Figure 14. In each case a circular collar or bubble of coating was raised about the central point of the collision. The Gaco N-79 Neoprene coating appeared to suffer the least damage in that the cut in the coating was a semi-circle rather than a complete

At a velocity of 530 ft/sec the raised collar or bubble of coating in the Gaco N-79 neoprene was of about the same diameter as that produced in it at a velocity of 490 ft/sec but the cut in the coating was a complete circle. The raised section of coating in the Goodyear 23-56 neoprene was nearly twice as large as that produced in Gaco N-79 neoprene at this velocity. This may indicate that the adhesion bonds between the metal and primer and/or between the primer and topcoat of the Goodyear-23-56-Bostik-1007 system are weaker than those of the Gaco-N-79-Gaco-N-15 system. The adhesion failure of the Goodyear coating system appeared to be between the primer and the metal. The raised section of coating in the Gates KV-9433 white neoprene was more than four times larger than that which formed in Gaco N-79 neoprene at this velocity. There was no tearing of the white neoprene topcoat at the periphery of the coating bubble but this did occur in the case of Goodyear 23-56 neoprene. This may indicate either that the adhesion bonds of the white neoprene system are weaker than those of the Goodyear-23-56-Bostik-1007 system and permit the growth of a large bubble without undue stress to the topcoat or that the white neoprene topcoat has higher strength properties than the Goodyear 23-56 neoprene topcoat permitting the growth of a large bubble in spite of strong adhesion bonds.

At a velocity of 640 ft/sec there is no tearing of the Gaco N-79 neoprene at the periphery of the coating bubble but such tearing did occur both in the Goodyear 23-56 neoprene and in the Gates KV-9433 white neoprene. There is some abrasion of the neoprene surface around the circular cut in the coating in the case of the white neoprene and rather extensive abrasion in the

case of the Goodyear 23-56 neoprene, but no abrasion in the case of the Gaco N-79 neoprene.

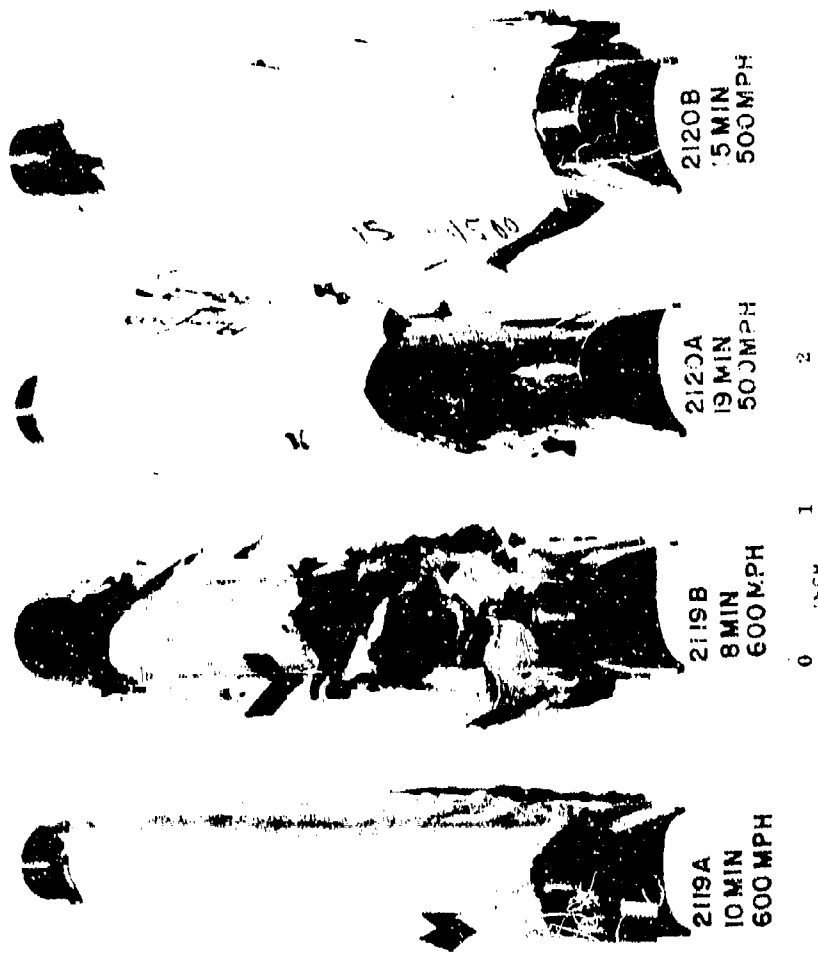
The specimens that were coated with white neoprene were numbered 2119 A and B and 2120 A and B. A picture of the four eroded specimens is shown in Figure 16. Only one specimen was tested at a velocity, in a rain density, and for a time interval comparable with that used for the other neoprene coating

systems. This was specimen 2119 A which was tested at a velocity of 600 mi/hr in 1-in/hr rain for 10 min. The coating on this specimen failed drastically in adhesion between the primer and the metal specimen-base. The coating loosened to form a large bubble that covered about three-fourths of the leading edge. Inspection of the eroded coating on this specimen with a stereoscopic microscope at a magnification of X20 revealed an indistinct chevron pattern in the neoprene at the low-speed end of the specimen and some abrasion of the coating surface on the leading edge. There were also randomly spaced gouges in the coating along the leading edge from about the center of the specimen to the high-speed end. The damage done to this specimen was obvious to the unaided eye whereas the specimens coated with the Gaco N-79-Gaco-N-15 and with the Goodyear-23-56-Bostik-1007 systems that were tested under the same conditions appeared to be undamaged to this degree of inspection.

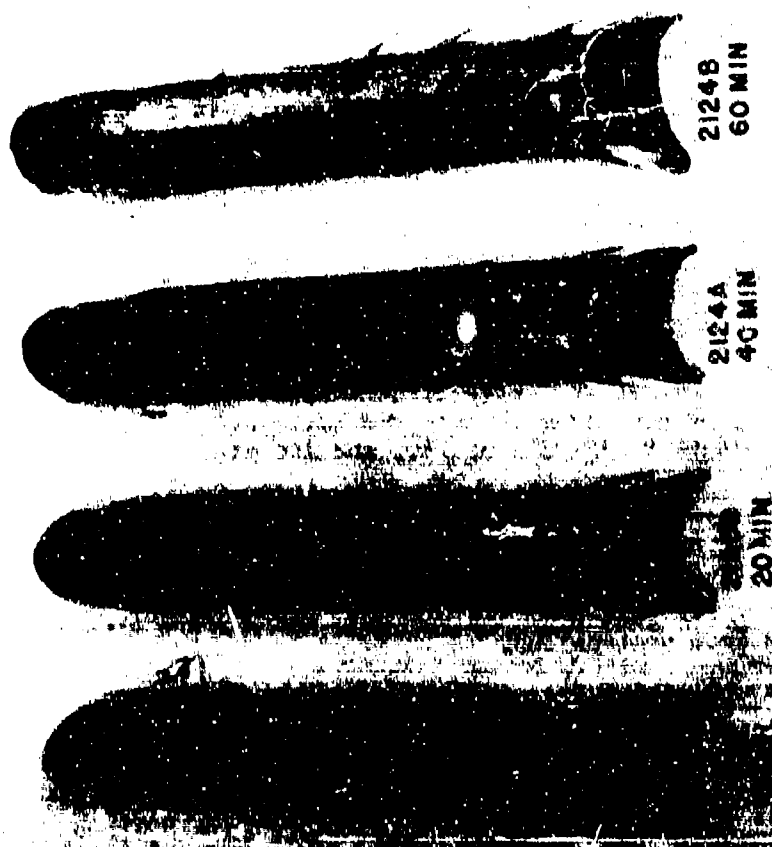
FIGURE 12 - ERODED SPECIMENS THAT WERE COATED WITH COCUREN 22-76 PROTECTANT

Specimen 2124 A was tested for 40 min under the same conditions of velocity and rain rate. Microscopic inspection of this specimen again revealed a scattering of small round holes down the leading edge. The chevron pattern in the neoprene at the low-speed end

was distinct. There was strong bubbling or lifting of the coating along the leading edge indicating loss of adhesion, and there was abrasion by scuffing up of the surface layer especially at the high-speed end. There were also some sutures or cracks in the coating.
